**Flood Control Project Maintenance
Levee Inspections**

Maintenance Issue Types Only, Levee Inspection Report By Mile - Spring 2019

Reclamation District No. 1602 Del Puerto

Waterway	Bank	Unit Miles	Inspection Start/End	Inspector
Unit No. 01 San Joaquin River	Left	6.24	04/16/2019 04/16/2019	Corey Fujitani

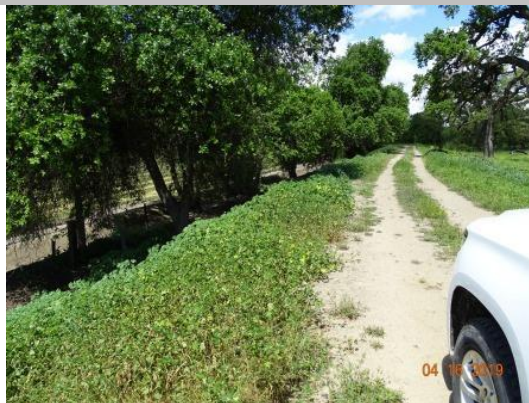
Photo 1 of 1 : SP_2019_RD1602_110_76_20190424_00113.jpg

LM Start	3.68	Rating **	U	Issue No.	76
LM End	3.92	Issue Type +	Ma	Location *	LS
Category	Earthen Levee			GPS Latitude/Longitude	
				Start	End
Item	Vegetation			37.456337 °	37.453342 °
				-121.044334 °	-121.042219 °
DWR ID	DWR_RD1602_01_s_2019_76				
Comment Code					
V1 : Control annual grass and weeds on the levee slopes and easements.					
Inspector Comment

View of landside slope looking downstream. (Spring 2019)

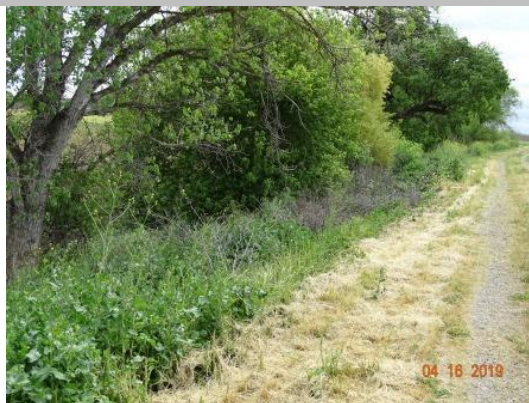
Photo 1 of 3 : SP_2019_RD1602_110_75_20190424_00116.jpg

LM Start	4.83	Rating **	U	Issue No.	75
LM End	5.93	Issue Type +	Ma	Location *	WS
Category	Earthen Levee			GPS Latitude/Longitude	
				Start	End
Item	Vegetation			37.441661 °	37.432447 °
				-121.036558 °	-121.026391 °
DWR ID	DWR_RD1602_01_s_2012_75				
Comment Code					
V2 : Remove the wild growth other than native grasses from the levee slopes.					
Inspector Comment

View of waterside slope looking upstream. (Spring 2019)

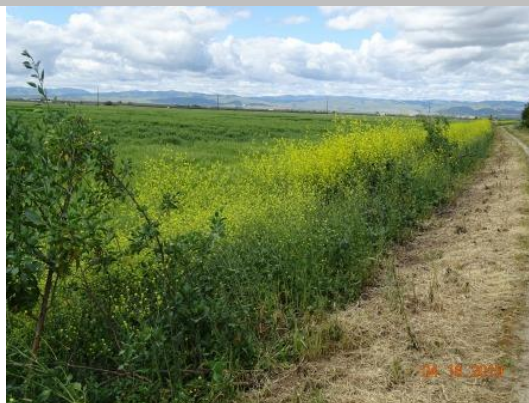
Photo 1 of 2 : SP_2019_RD1602_110_61_20190424_00117.jpg

LM Start	4.83	Rating **	U	Issue No.	61
LM End	6.22	Issue Type +	Ma	Location *	LS
Category	Earthen Levee			GPS Latitude/Longitude	
				Start	End
Item	Vegetation			37.441660 °	37.429165 °
				-121.036558 °	-121.029682 °
DWR ID	DWR_RD1602_01_s_2012_61				
Comment Code					
V2 : Remove the wild growth other than native grasses from the levee slopes.					
Inspector Comment

View of landside slope looking downstream. (Spring 2019)

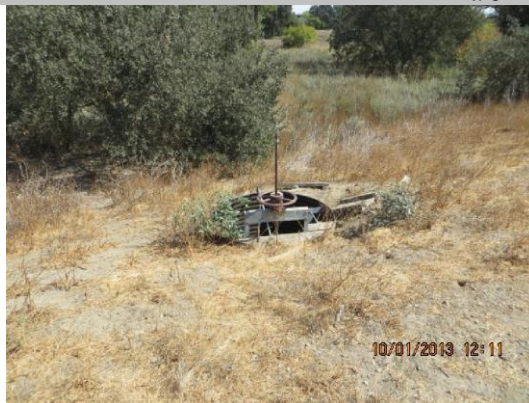
Photo 1 of 3 : UCIP_SP_2019_51336_36822.jpg

Comment Code						
Inspector Comment						
FS_ID:51336 DS_ID:20208 EP_NO: N/A Repair Type: Non-Urgent Crossing Status: Found UCIP Comments: 11/18/2016 Same as previous inspection soil and debris prevent flap gate from properly fuctioning and slide gate won't close due to sediment build up. Crossing has been downgraded from Urgent to Non-Urgent due to no pipe or levee integrity issues observed during the site visit. Need to contact owner to determine status of crossing. If crossing is no longer in use owner will need to coordinate with CVFPB to properly abandon or remove according to Title 23 requirements. (O. Magana - DWR UCIP)10/01/2013 Soil and debris prevent flapgate from proper function. Slide gate won't close completely due to sediment buildup. CMP riser needs cover. (W. Wylie - DWR UCIP) FIELD_STRUCT_DESC: 24-inch steel pipe through levee, 11.6 feet below crown. Concrete headwall on the landside (LS) end. Concrete "U" headwall and flap gate located on the waterside (WS) end. Slide gate in 60-inch corrugated metal pipe (CMP) riser is located on the WS slope. [Additional Reference(s): DWR Levee Log, 1992. USACE San Joaquin River O&M Manual Unit 13, April 1964, (HLM 5.23), Drawing No. 7-4-1784]. FS Date: 11/18/2016

Slide gate in CMP riser on WS slope. Outlet visible under tree in background.

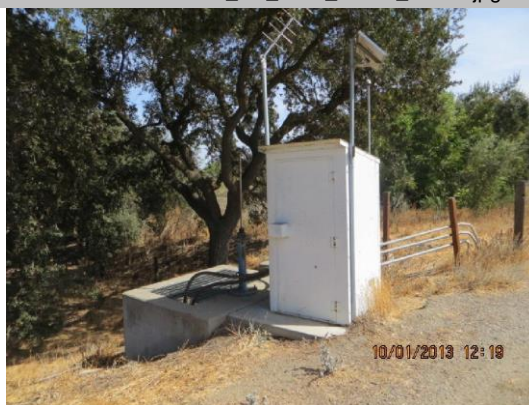
Photo 1 of 2 : UCIP_SP_2019_21665_36829.jpg

Comment Code					
Inspector Comment					
FS_ID:21665 DS_ID:20209 EP_NO: 8192 Repair Type: No Action Needed Crossing Status: Found UCIP Comments: FIELD_STRUCT_DESC: 1 of 2: 36-inch by 36-inch reinforced concrete box drainage culvert through the levee, 15.8 feet below the crown. Slide gate in a 6-foot by 7-foot concrete surge box on the waterside (WS) slope. 36-inch concrete pipes buried on both sides of the levee and connected to the reinforced concrete box culvert. Constructed through the levee section. (two 36-inch by 36-inch culvert [HLM 5.27] authorized under Automatic Board Order (ABO) issued as Permit No. 8192, 1972 - Stanislaus County). [Additional Reference(s): DWR Levee Log, 1992. USACE San Joaquin O&M Manual 13, April 1964, (HLM 5.27), Drawing No. 7-4-1784]. FS Date: 10/1/2013

Shed with slide gate in Concrete riser on WS shoulder.

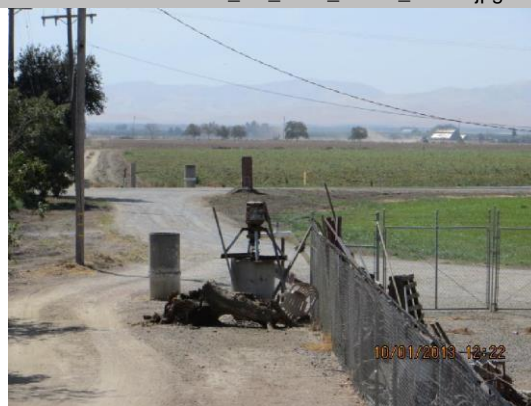
Photo 2 of 2 : UCIP_SP_2019_21665_36828.jpg

Item	DWR UCIP LMA Responsibility			37.436246 °	37.436246 °	
				-121.036193 °	-121.036193 °	
DWR ID	20209					
Comment Code						
Inspector Comment						
FS_ID:21665 DS_ID:20209 EP_NO: 8192 Repair Type: No Action Needed Crossing Status: Found UCIP Comments: FIELD_STRUCT_DESC: 1 of 2: 36-inch by 36-inch reinforced concrete box drainage culvert through the levee, 15.8 feet below the crown. Slide gate in a 6-foot by 7-foot concrete surge box on the waterside (WS) slope. 36-inch concrete pipes buried on both sides of the levee and connected to the reinforced concrete box culvert. Constructed through the levee section. (two 36-inch by 36-inch culvert [HLM 5.27] authorized under Automatic Board Order (ABO) issued as Permit No. 8192, 1972 - Stanislaus County). [Additional Reference(s): DWR Levee Log, 1992. USACE San Joaquin O&M Manual 13, April 1964, (HLM 5.27), Drawing No. 7-4-1784]. FS Date: 10/1/2013

Likely risers for pipe off LS toe.

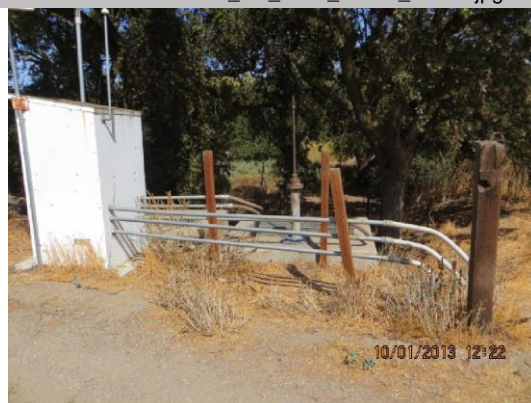
Photo 1 of 2 : UCIP_SP_2019_21668_36835.jpg

Comment Code					
Inspector Comment					
FS_ID:21668 DS_ID:20222 EP_NO: 8192 Repair Type: No Action Needed Crossing Status: Found UCIP Comments: FIELD_STRUCT_DESC: 2 of 2: 36-inch by 36-inch reinforced concrete box drainage culvert through the levee, 15.8 feet below the crown. Slide gate in a 6-foot by 7-foot concrete surge box on the waterside (WS) slope. 36-inch concrete pipes buried on both sides of the levee and connected to the reinforced concrete box culvert. Constructed through the levee section. (two 36-inch by 36-inch culvert [HLM 5.27] authorized under Automatic Board Order (ABO) issued as Permit No. 8192, 1972 - Stanislaus County). [Additional Reference(s): DWR Levee Log, 1992. USACE San Joaquin O&M Manual 13, April 1964, (HLM 5.27), Drawing No. 7-4-1784]. FS Date: 10/1/2013

Slide gate in Concrete vault on WS shoulder.

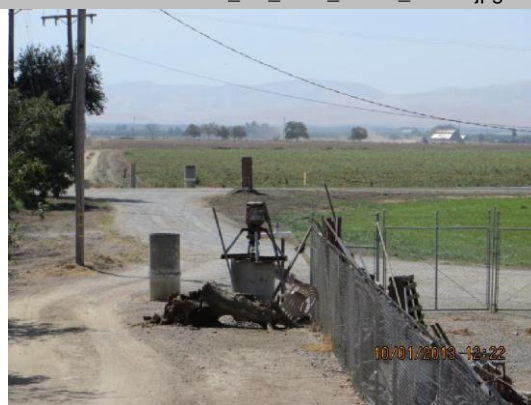
Photo 2 of 2 : UCIP_SP_2019_21668_36834.jpg

Possible concrete risers for pipe off LS toe.

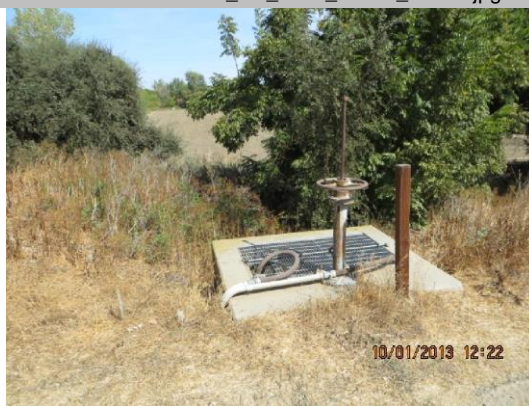
Photo 1 of 3 : UCIP_SP_2019_21672_36848.jpg

LM Start	5.24	Rating **	A/W	Issue No.	212
LM End	5.24	Issue Type +	Ma	Location *	
Category	Supplemental			GPS Latitude/Longitude	
				Start	End
Item	DWR UCIP LMA Responsibility			37.436129 °	37.436129 °
				-121.036065 °	-121.036065 °
DWR ID	20210				
Comment Code					
Inspector Comment					
FS_ID:21672 DS_ID:20210 EP_NO: N/A Repair Type: No Action Needed Crossing Status: Found UCIP Comments: FIELD_STRUCT_DESC: 30-inch by 30-inch reinforced concrete box drainage culvert through the levee, 12.9 feet below the crown. Slide gate in a concrete surge box on the waterside (WS) slope. Concrete discharge boxes on both ends. [Additional Reference(s): DWR Levee Log, 1992. USACE San Joaquin O&M Manual 13, April 1964, (HLM 5.28), Drawing No. 7-4-1784]. FS Date: 10/1/2013

Slidegate in concrete riser on WS shoulder.

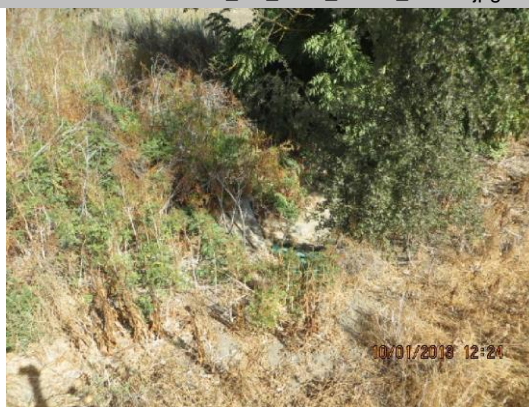
Photo 2 of 3 : UCIP_SP_2019_21672_36847.jpg

Concrete outlet on WS toe.

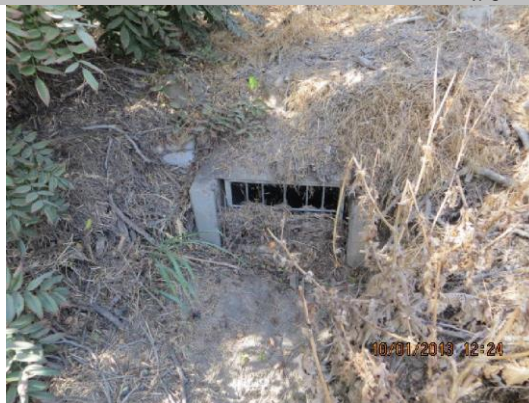
Photo 3 of 3 : UCIP_SP_2019_21672_36846.jpg

LM Start	5.24	Rating **	A/W	Issue No.	212 (cont)
LM End	5.24	Issue Type +	Ma	Location *	
Category	Supplemental			GPS Latitude/Longitude	
				Start	End
Item	DWR UCIP LMA Responsibility			37.436129 °	37.436129 °
				-121.036065 °	-121.036065 °
DWR ID	20210				
Comment Code					
Inspector Comment					
FS_ID:21672 DS_ID:20210 EP_NO: N/A Repair Type: No Action Needed Crossing Status: Found UCIP Comments: FIELD_STRUCT_DESC: 30-inch by 30-inch reinforced concrete box drainage culvert through the levee, 12.9 feet below the crown. Slide gate in a concrete surge box on the waterside (WS) slope. Concrete discharge boxes on both ends. [Additional Reference(s): DWR Levee Log, 1992. USACE San Joaquin O&M Manual 13, April 1964, (HLM 5.28), Drawing No. 7-4-1784]. FS Date: 10/1/2013

Concrete inlet on LS toe.

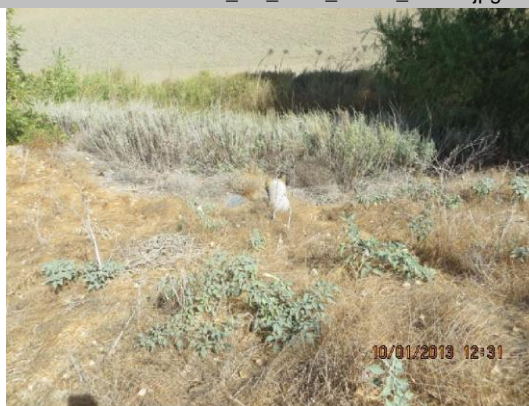
Photo 1 of 1 : UCIP_SP_2019_21674_36854.jpg

LM Start	5.46	Rating **	M	Issue No.	213
LM End	5.46	Issue Type +	Ma	Location *	
Category	Supplemental			GPS Latitude/Longitude	
				Start	End
Item	DWR UCIP LMA Responsibility			37.433646 °	37.433646 °
				-121.033846 °	-121.033846 °
DWR ID	20211				
Comment Code					
Inspector Comment					
FS_ID:21674 DS_ID:20211 EP_NO: N/A Repair Type: Non-Urgent Crossing Status: Found UCIP Comments: 10/01/2013 Pipe appears abandoned and if so should be done so properly. (W. Wylie - DWR UCIP) FIELD_STRUCT_DESC: *ABANDONED* 12-inch drainage pipe of an unknown material through the levee, 6.9 feet below the crown. Flap gate on the waterside (WS) end. Could not locate, March 1984. (Reclamation District No. 1602). [Additional Reference(s): DWR Levee Log, 1992. USACE San Joaquin O&M Manual 13, April 1964, (HLM 5.50), Drawing No. 7-4-1784]. FS Date: 10/1/2013

Pipe and flapgate visible on WS toe.

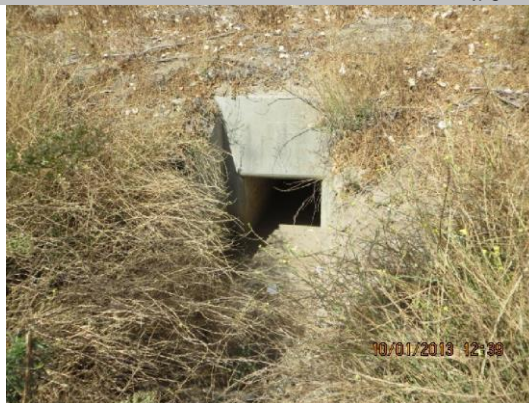
Photo 3 of 3 : UCIP_SP_2019_51337_36876.jpg

Comment Code					
Inspector Comment					
FS_ID:51337 DS_ID:20212 EP_NO: N/A Repair Type: Non-Urgent Crossing Status: Found UCIP Comments: 11/18/2016 Crossing has been downgraded from Urgent to Non-Urgent flap gate is functional. Recommend clearing dense vegetation from WS and LS slopes. (O. Magana - DWR UCIP)10/01/2013 Flapgate has minor blockage preventing gate from fully closing. (W. Wylie - DWR UCIP) FIELD_STRUCT_DESC: 30-inch square reinforced concrete box culvert through levee, 9 feet below crown. Slide gate in concrete surge box is located on the waterside (WS) slope. Concrete "U" headwalls are located on both the waterside (WS) and landside (LS) ends. Flap gate is located on the WS end. [Additional Reference(s): DWR Levee Log, 1992. USACE San Joaquin River O&M Manual Unit 13, April 1964, (HLM 5.28), Drawing No. 7-4-1784]. FS Date: 11/18/2016

Concrete U-shaped headwall on LS toe.
